IRISystem Photographs

Evaluation Plan for IRISystem Infrared Brake Screening Project

DTFH61-96-C-00044, Task Order Battelle 7704, Subtask 19

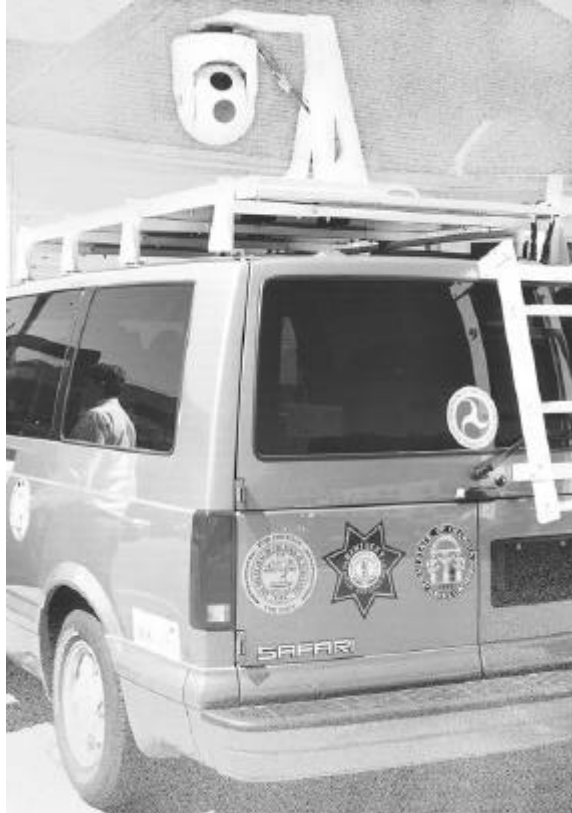
Figure A-1. The IRISystem, showing the housing minivan, and the camera mount on the roof (Photo courtesy of J. Bibb).

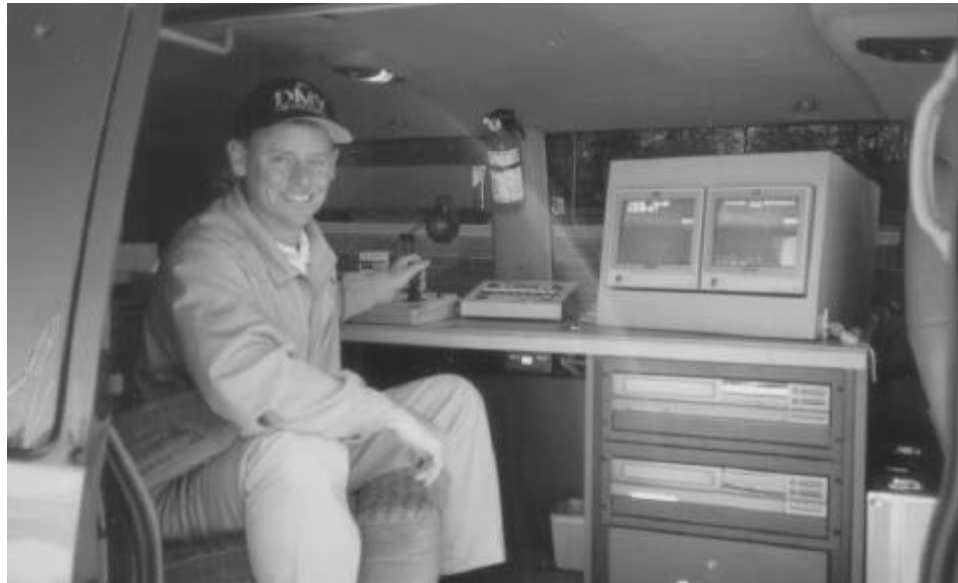
Figure A-2. The IRISystem minivan interior with video screens, VCRs and the joystick which operates the camera.

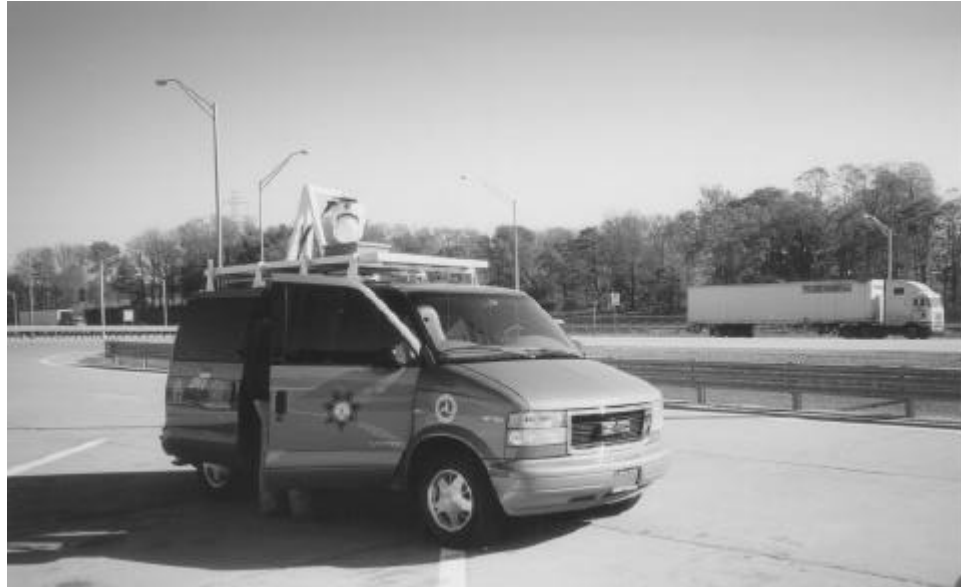
Figure A-3. The IRISystem, set-up at a scale site in Kentucky.

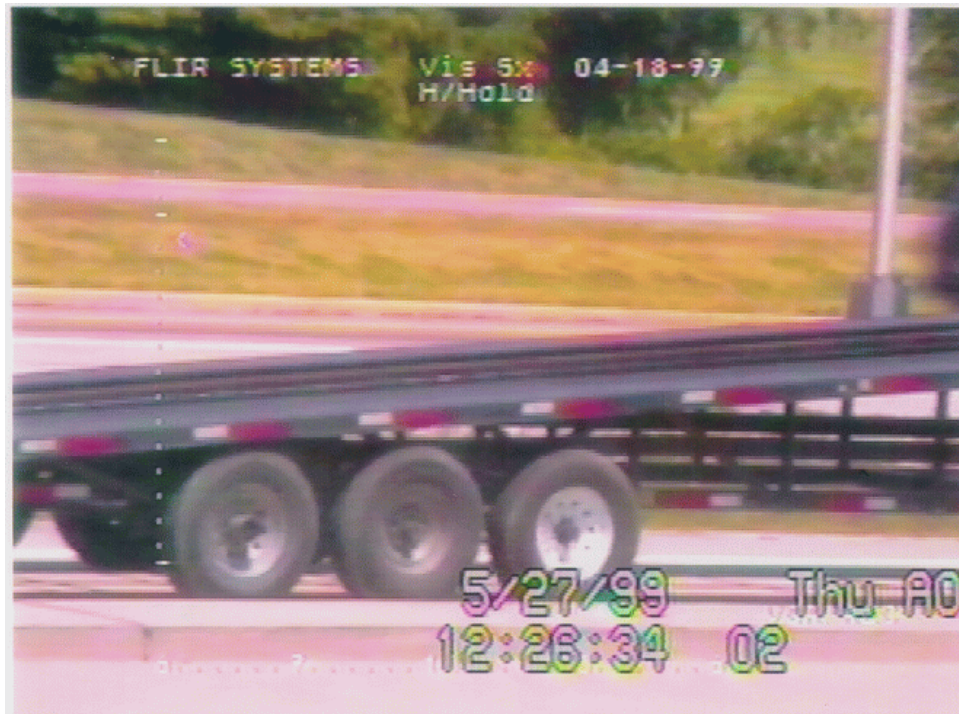
Figure A-4. Color and corresponding thermal images of a screened CMV.

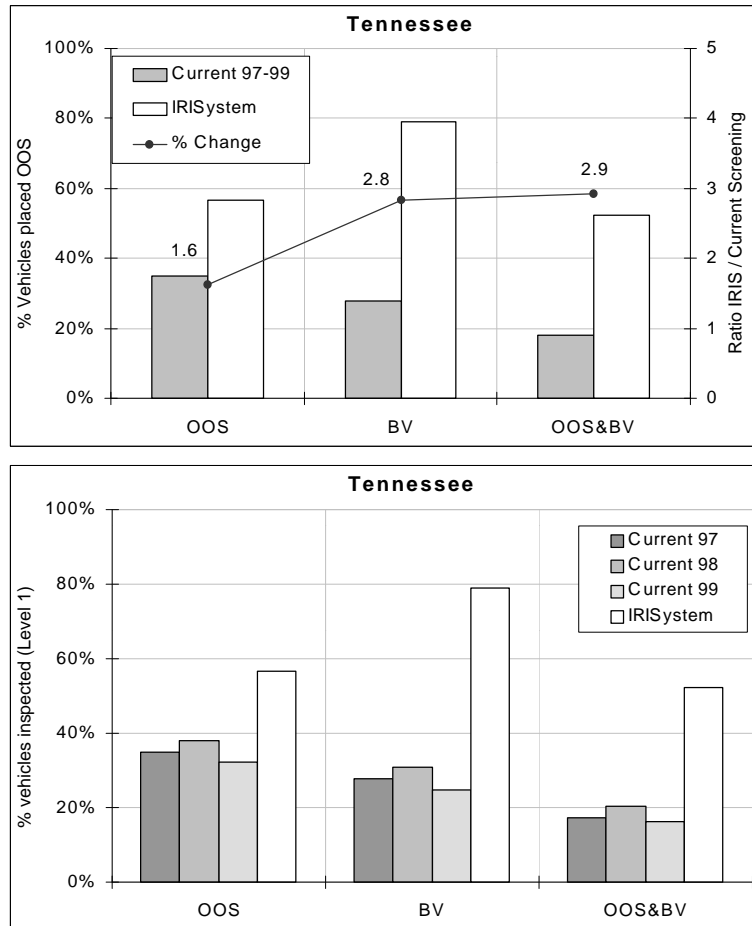
Figure K-5. Tennessee

Top plot **Percentage of CMV placed OOS for Tennessee after IRISystem screening (no blind vehicles) and after current screening (SAFETYNET data, for 1997-1999 and Level 1 inspections).**

Bottom plot **Same as top plot, but showing SAFETYNET data per year.**
